RETROFIT TECHNIQUES FOR DISTORTION-INDUCED FATIGUE DAMAGE IN STEEL
BRIDGE GIRDERS

Chapter One:
Use of Composite Block Retrofit for Repairing Distortion –Induced Fatigue Damage at
Cross-Frame Connection Plates

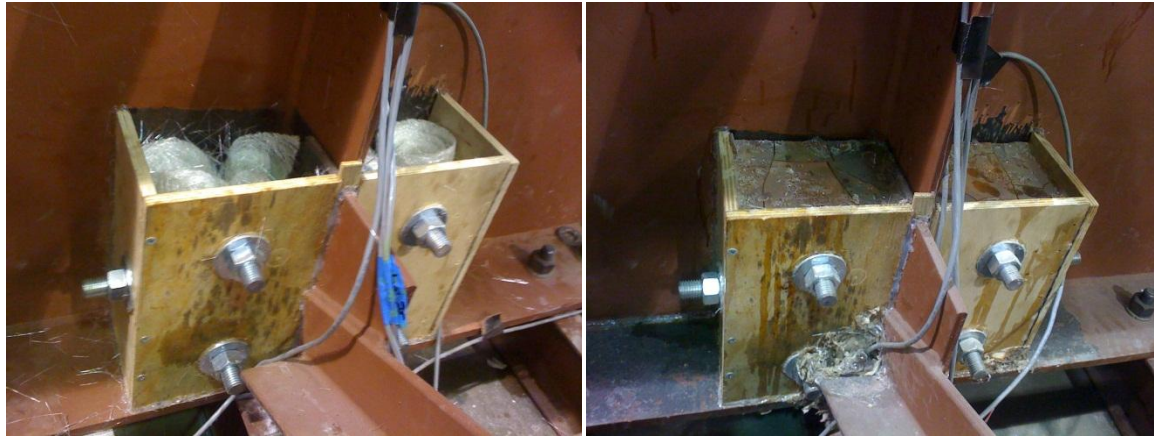
Figure 1- 7 View of the interior of the girder segment: a) FRP block formed; photograph taken prior to casting the WEST resin; b) Cured FRP blocks.

In Trial 1, the girder specimen was cycled in the unretrofitted condition so that cracking could be initiated and propagated. A crack formed along the connection plate-to-web weld and was allowed to propagate to a length of 57-mm (2 1/4-in). During Trial 1, the girder subassembly was inspected every one thousand cycles using UV light and dye penetrant. Once the desired crack length was achieved, the composite block retrofit was cast on the interior face of the girder on both sides of the connection plate (Fig. 1-7), and Trial 2 was begun.

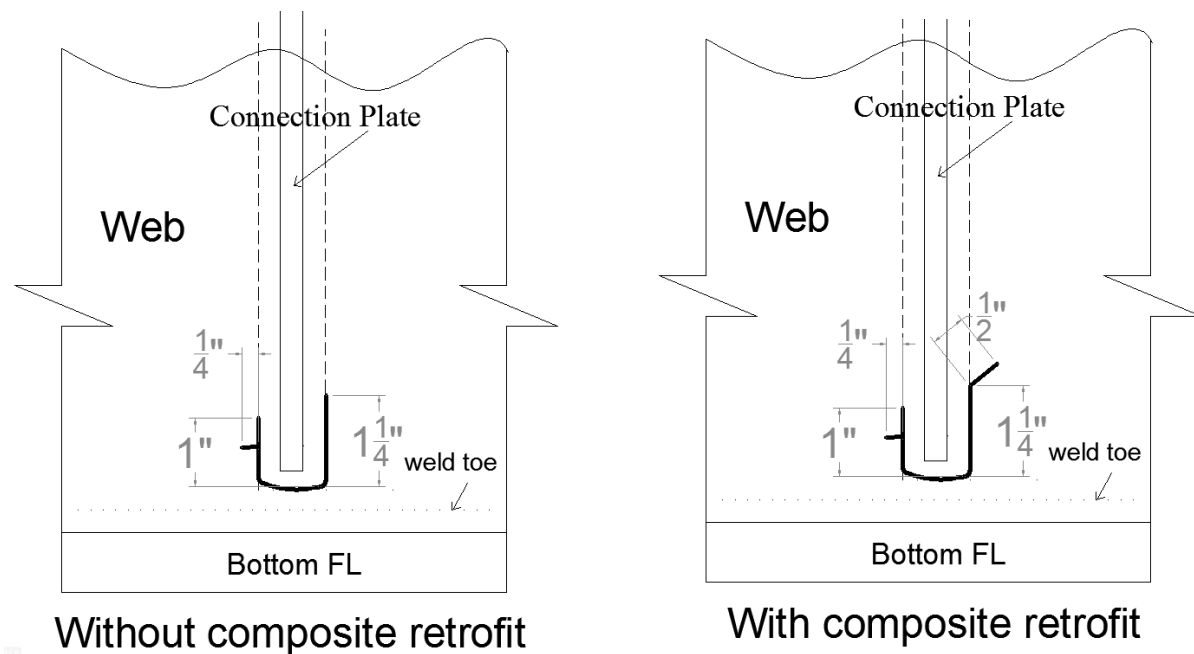
Results of the physical testing showed that the distortion-induced fatigue life of this girder was significantly improved. The crack propagation rate was slowed significantly when compared to the crack growth rate observed in the test girder without the retrofit. Figure 1-9(a) presents the crack pattern that was recorded during the inspection performed directly before applying composite block retrofit (after Trial 1 and before Trial 2), and Figure 1-9(b) presents the crack pattern recorded after Trial 2 was completed with the retrofit. It can be seen that the only crack that initiated after application of the retrofit was a small spider crack on the right side of the transverse stiffener (Fig.1-10).

Figure 1-9 Recorded crack patterns: a) After Trial 1 (without composite retrofit – 1.2 million cycles) b) After Trial 2 (with composite retrofit – additional 1.2 million cycles)

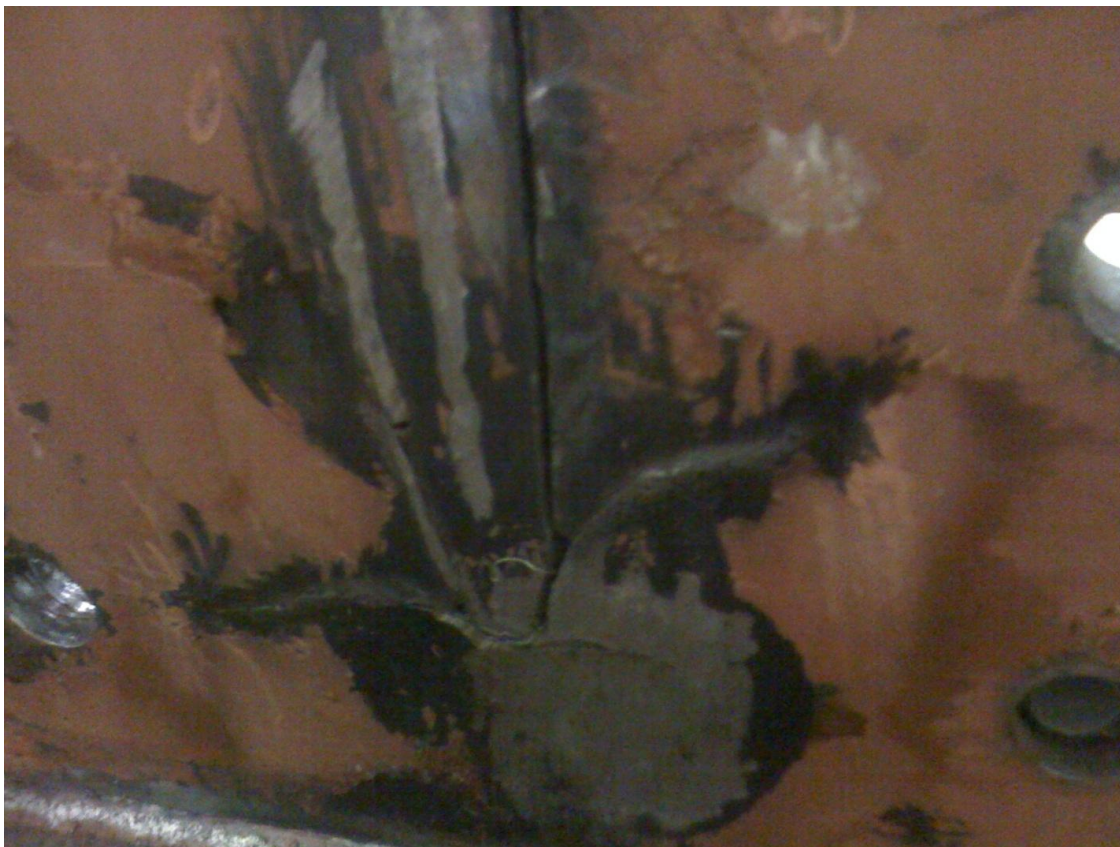
A cross-frame was connected to the connection plate; loads were applied to the assembly via the free end of the cross-frame, through an attached WT section. The cross-frame was made up of three L76x76x10-mm (L3x3x $\frac{3}{8}$ -in) angles, of which two were in an X-configuration, and one horizontal member. This assembly had previously been subjected to fatigue testing over approximately 8 million cycles, under a load range from 2.2-kN (0.5-kip) to 25.4-kN (5.7-kip), which resulted in 267-mm (10 $\frac{1}{2}$ -in) deep cracks in the girder's web as shown in Fig.2-3.

Figure 2-3 Existing cracks on exterior face of the girder's web

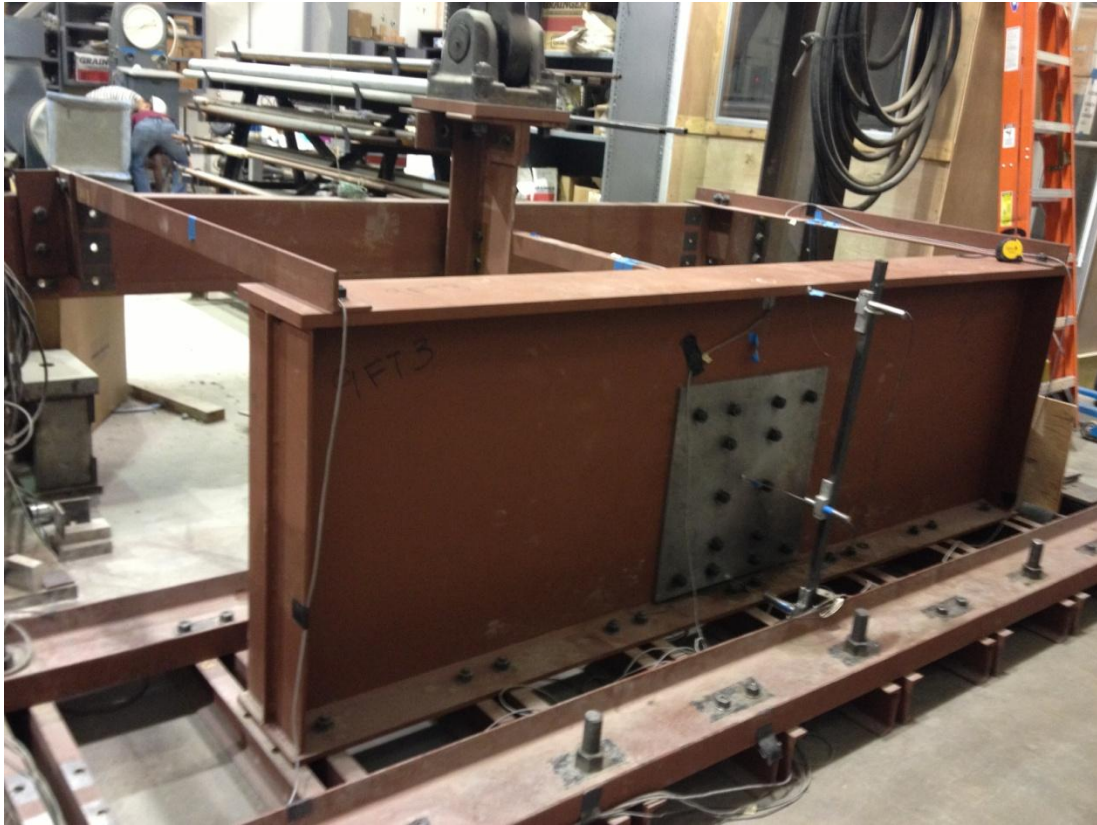
Figure 2-5 View on the exterior face of the girder's web with a steel back plate

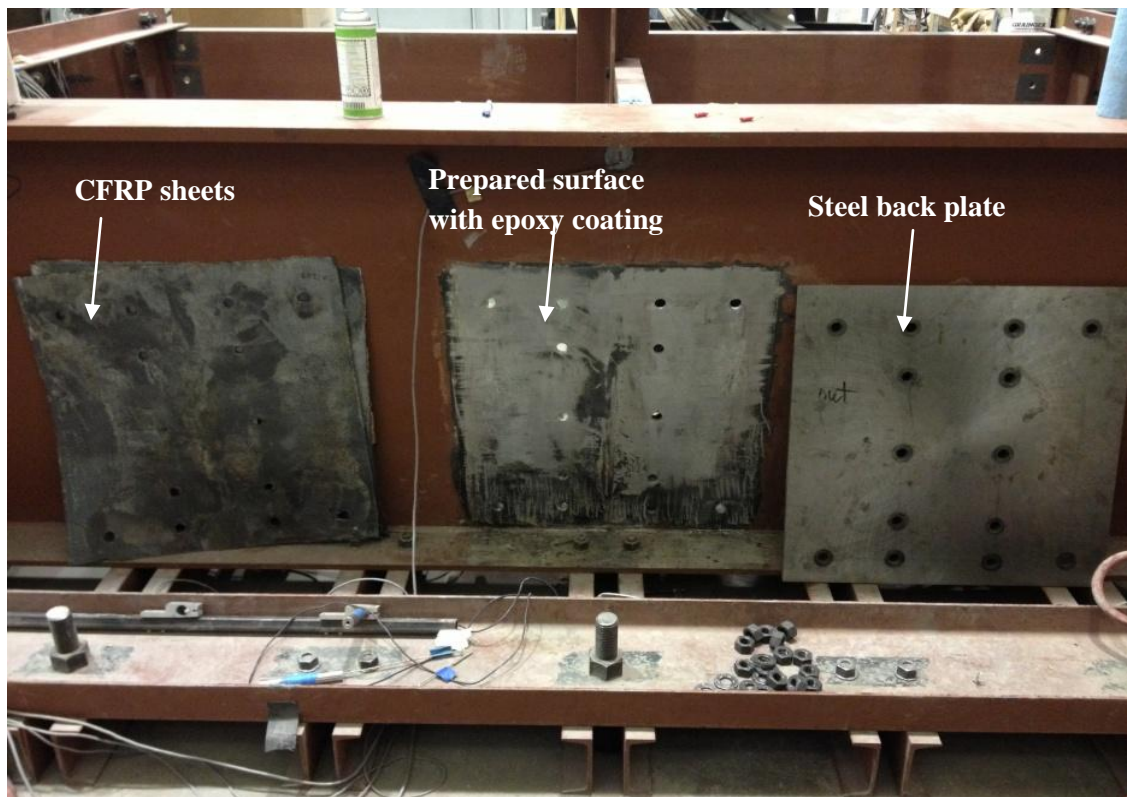
Figure 2-7: Test Trial 2- view of the exterior face of the girder's web

In the retrofit that included steel elements applied over the CFRP layers, an additional step of applying the steel elements was performed. The steel angles and back plate were attached over the graphite fibers by pre-tensioning the bolts (Fig.2-7 and Fig.2-8). The pressure applied from the pretension bolts activated the matrix material (epoxy) and caused the matrix to flow entirely around the fibers. The retrofit was left to cure for 48 hours before the test began.

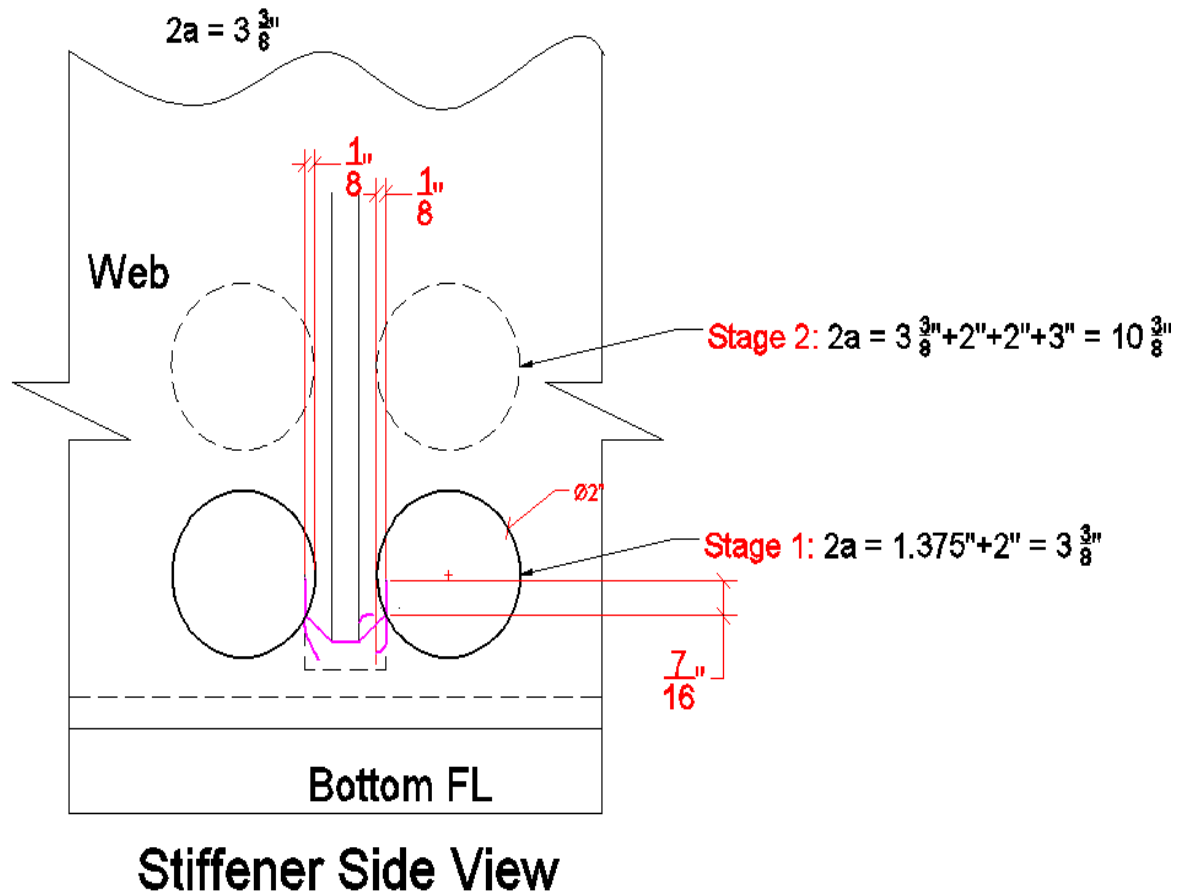
9ft Specimen # 5 : 2" Crack-stop holes

Figure 3-4 Interior girder view where holes were drilled

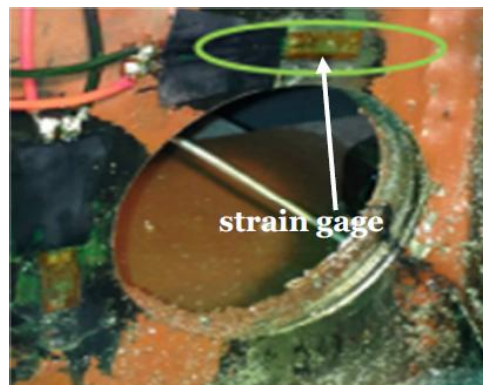
Figure 3-9 Crack-arrest hole on the left side of the connection plate (Segment 2)

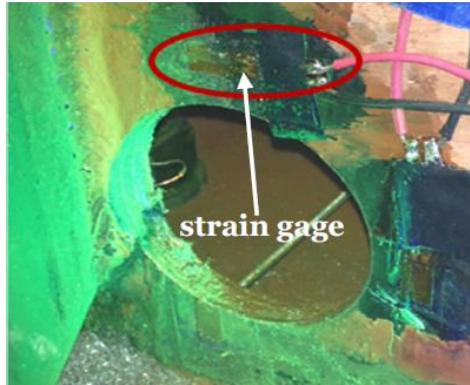
Figure 3-10 Crack-arrest hole on the right side of the connection plate (Segment 2)

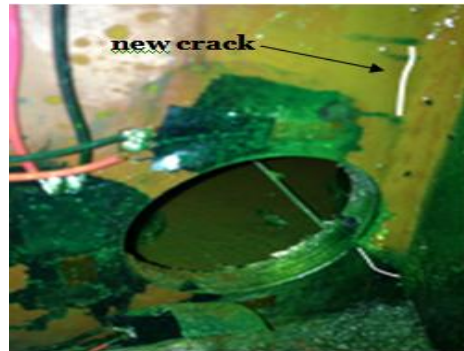
Figure 3-11 Cracking forming after the first pair of crack-arrest holes had been drilled and tested (Segment 2)

Strain gages were installed around the holes at 90 degree apart to measure the deformation around the holes. The data from two strain gages were presented in this paper. The gages were named as Left CSH and Right CSH, both located on the top of the holes next to the connection plate-web weld (Fig.3-9 and Fig.3-10). Left CSH was the gage on the left side of the connection plate, and Right CSH was on the right side. Strain data collected from these two strain gages indicated that the magnitude of strain was closed to the strain at yield (Fig.3-12). Also, the strain on the left crack-arrest hole was higher than the strain value obtained on the right crack-arrest hole, which was corroborated by the fact that a crack was first seen on the left side of the connection plate before it was found to have initiated on the right side of the connection plate (Fig.3-11).

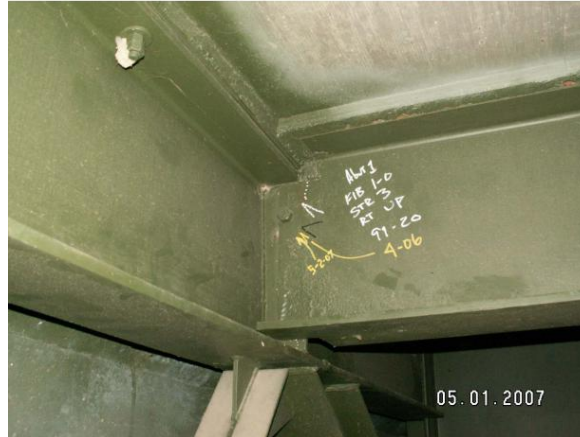
Figure 4-2 Fatigue cracking at the coped stringer near a floorbeam-to-stringer connection
